TECHNICAL REPORT HL-84-4

OLD RIVER DIVERSION, MISSISSIPPI RIVER

BARGE BARRIER STUDY

Hydraulic Model Investigation

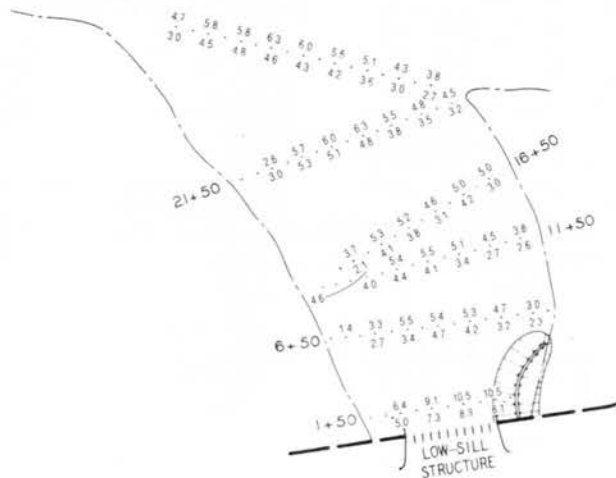
INFLOW CHANNEL VELOCITIES
BANK-FULL STAGE
TOTAL DISCHARGE 1,077,000 CFS

4.5 VELOCITY OBTAINED AT 0.6 DEPTH
2.3 VELOCITY OBTAINED AT BOTTOM DEPTH

20. Since the pier-supported barge barrier produced a very high degree of assurance that loose barges would not enter the inflow channel, additional tests were conducted to determine the barrier's effect on the hydraulic conditions of the inflow channel. These tests evaluated water-surface profiles, velocity and current directions, and point velocities in the inflow channel. Water-surface profiles and velocities and current directions were obtained for low-sill structure headwater stages of 16, 24, 28, 32, and 40 ft for conditions of no barrier, and the barrier in place with the low-sill structure in orifice operation. Water-surface profiles indicated no change in the water surface of the inflow channel, gages 10 and 12 (Plate 4 and Table 1). Comparison of water-surface profiles for the 24- and 40-ft stages indicates that no significant change occurred in the Mississippi River or Old River Diversion channels with the barrier in place. The barge barrier caused no significant change in the velocities and current directions in the inflow channel. Results of orifice control operation, shown in Plates 5-8, indicated the maximum velocities 500 ft upstream of the low-sill structure to be 3.6 and 5.5 fps for the 24- and 40-ft stages, respectively, for no barrier, and 3.4 and 5.3 fps, respectively, for the barrier in place. Point velocities at 0.6 depth and bottom depth were obtained in the inflow channel for bank-full, 1973 Flood crest, and Project Flood crest stages with and without the barrier in place with all the low-sill and overbank structures gates open. Results, shown in Plates 9-11, indicated maximum 0.6-depth velocities at 650 ft upstream of the low-sill structure to be 6.3, 5.4, and 5.7 fps for the bank-full, 1973 Flood, and Project Flood stages, respectively, for no barrier and 6.7, 5.1, and 5.8 fps with the barrier in place.
